**Flood Control Project Maintenance
Levee Inspections**

Fall 2009 Levee Maintenance Deficiency Summary Report

San Joaquin River Basin

Reclamation District No. 2089 Stark

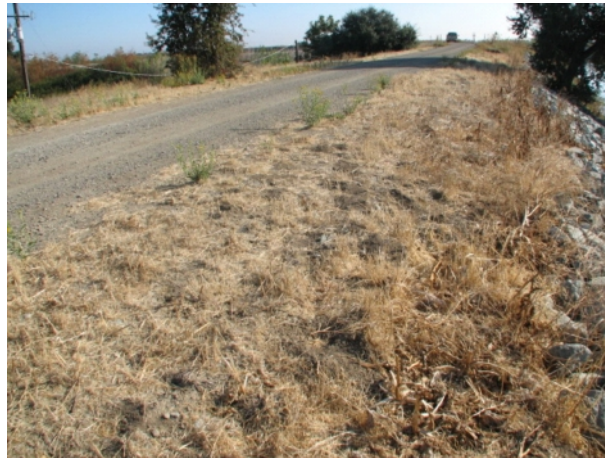
Levee Mile Report Line	3
Start Levee Mile	0.07
End Levee Mile	0.07
Location	Water Side
Category	Earthen Levee
Item	Animal Control

Animal burrows on waterside slope near crown.

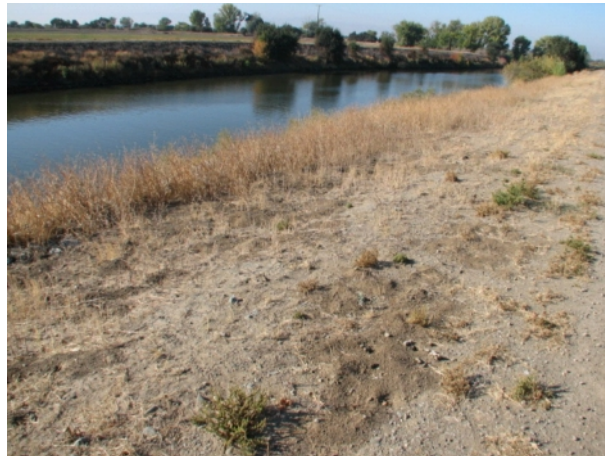
Levee Mile Report Line	5
Start Levee Mile	0.18
End Levee Mile	0.18
Location	Crown
Category	Earthen Levee
Item	Animal Control

Burrows on levee crown.

5	0.18	0.18	Earthen Levee	Animal Control	CR	M	No rodents visible, but rodent burrows visible; need to backfill and compact or grout borrows.	37.810833 ° -121.387897 °	37.810833 ° -121.387897 °	936 Y
6	0.22	0.22	Supplemental	DWR Erosion Survey	WS	M	Inspector Comments: 2009: localized sloughing at the toe; recommend annual assessment and monitoring of erosion site, per CLRO CES Evaluation 2008 Report; previously rated "M" [2009 SiteID:RD2089U1RM30.02]	37.810460 ° -121.388870 °	37.810460 ° -121.388870 °	2
7	0.23	0.23	Earthen Levee	Animal Control	CR	M	No rodents visible, but rodent burrows visible; need to backfill and compact or grout borrows.	37.810528 ° -121.388817 °	37.810528 ° -121.388817 °	937
8	0.23	0.23	Earthen Levee	Trim / Thin Trees	LS	M	Trim trees to at least five feet above ground level.	37.810532 ° -121.388823 °	37.810532 ° -121.388823 °	938
9	0.24	0.24	Earthen Levee	Trim / Thin Trees	WS	M	Trim trees to at least five feet above ground level.	37.810490 ° -121.389018 °	37.810490 ° -121.389018 °	939

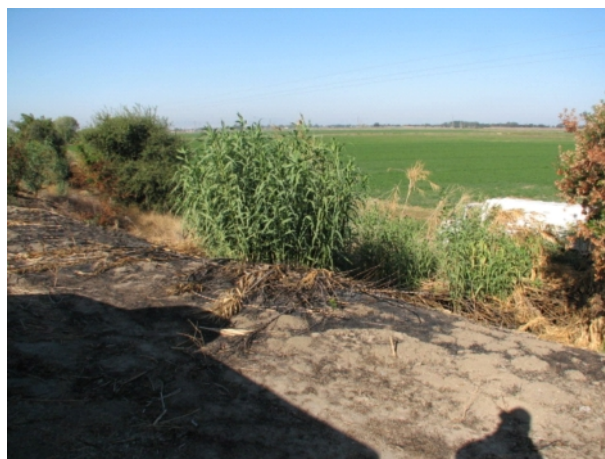
Levee Mile Report Line	10
Start Levee Mile	0.24
End Levee Mile	0.24
Location	Land Side
Category	Earthen Levee
Item	Vegetation

Photo of thick bamboo stands on landside slope.

10	0.24	0.24	Earthen Levee	Vegetation	LS	M	Remove the wild growth other than native grasses from the levee slopes. Inspector Comments: Bamboo remains as an obstruction despite recent burning.	37.810488 ° -121.389018 °	37.810488 ° -121.389018 °	940 Y
11	0.25	0.25	Earthen Levee	Vegetation	LS	M	Elderberries are blocking visibility and flood fight capability.	37.810408 ° -121.389237 °	37.810408 ° -121.389237 °	941
12	0.26	0.26	Earthen Levee	Vegetation	WS	M	Remove the wild growth other than native grasses from the levee slopes. Inspector Comments: Brush is growing despite the rock protection.	37.810380 ° -121.389282 °	37.810380 ° -121.389282 °	942
13	0.27	0.27	Earthen Levee	Vegetation	LS	M	Elderberries are blocking visibility and flood fight capability.	37.810343 ° -121.389470 °	37.810343 ° -121.389470 °	943
14	0.29	0.34	Earthen Levee	Vegetation	LS	U	Remove the wild growth other than native grasses from the levee slopes. Inspector Comments: Brush and trees are thick in this reach. Access and visibility is completely blocked.	37.810267 ° -121.389753 °	37.810012 ° -121.390697 °	944 Y

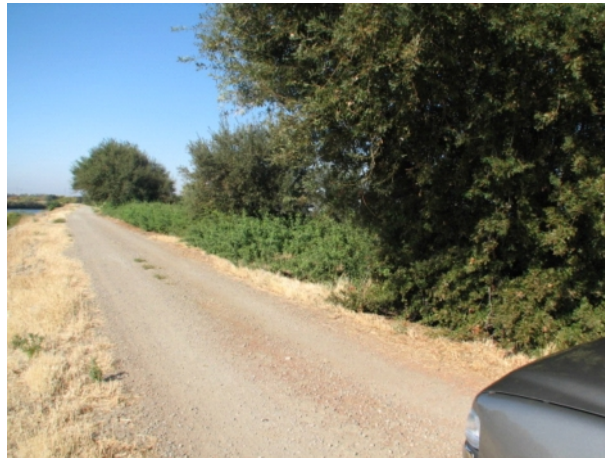
Levee Mile Report Line	14
Start Levee Mile	0.29
End Levee Mile	0.34
Location	Land Side
Category	Earthen Levee
Item	Vegetation

Photo of thick brush and trees on landside slope.

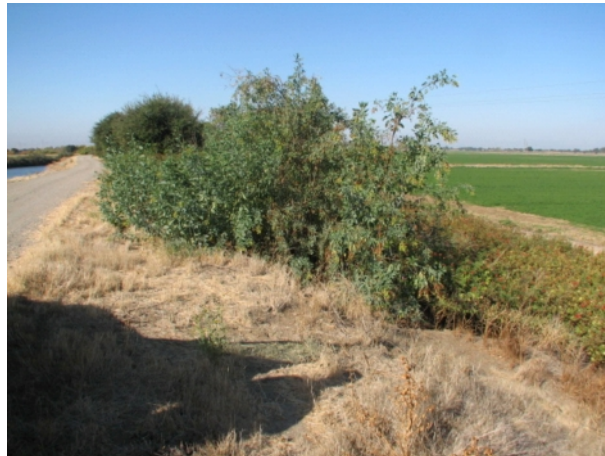
Levee Mile Report Line	16
Start Levee Mile	0.36
End Levee Mile	0.37
Location	Land Side
Category	Earthen Levee
Item	Vegetation

Photo of some obstructive elderberry or tobacco leaf on levee slope

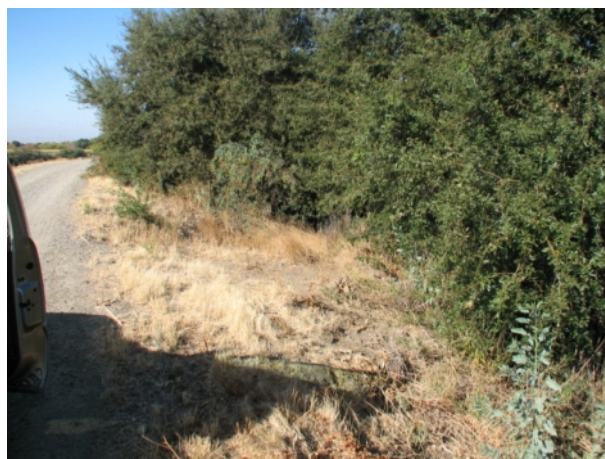
Levee Mile Report Line	19
Start Levee Mile	0.41
End Levee Mile	0.47
Location	Land Side
Category	Earthen Levee
Item	Trim / Thin Trees

Photo of completely obstructive vegetation on levee slope.

19	0.41	0.47	Earthen Levee	Trim / Thin Trees	LS	U	Thin trees to allow visibility of the ground and room to flood fight. Inspector Comments: Trees, Elderberries, Blackberries obstruct access and visibility.	37.809793 ° -121.391717 °	37.809592 ° -121.392822 °	948 Y
20	0.41	0.41	Supplemental	DWR Erosion Survey	WS	M	Inspector Comments: 2009: no change observed; recommend annual assessment and monitoring of erosion site, per CLRO CES Evaluation 2008 Report; same as RM29.84, LM0.30; previously rated "M" [2009 SiteID:RD2089U1RM29.83]	37.809530 ° -121.392160 °	37.809530 ° -121.392160 °	5
21	0.49	0.49	Earthen Levee	Trim / Thin Trees	WS	M	Thin trees to allow visibility of the ground and room to flood fight.	37.809658 ° -121.393023 °	37.809658 ° -121.393023 °	949 Y
22	0.54	0.61	Earthen Levee	Trim / Thin Trees	WS	U	Trim trees to at least five feet above ground level.	37.810137 ° -121.394150 °	37.810195 ° -121.395417 °	11 Y

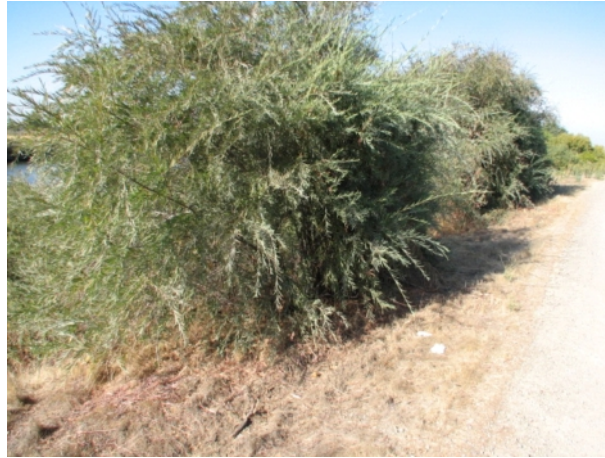
Levee Mile Report Line	21
Start Levee Mile	0.49
End Levee Mile	0.49
Location	Water Side
Category	Earthen Levee
Item	Trim / Thin Trees

Trees within 20-ft of levee crown on the waterside slope obstruct visibility and access.

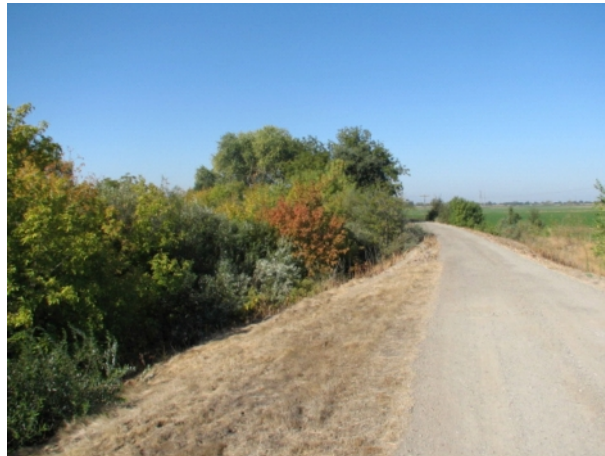
Levee Mile Report Line	22
Start Levee Mile	0.54
End Levee Mile	0.61
Location	Water Side
Category	Earthen Levee
Item	Trim / Thin Trees

Photo of trees within 20-ft of the levee crown on waterside slope. Access and visibility are obstructed.

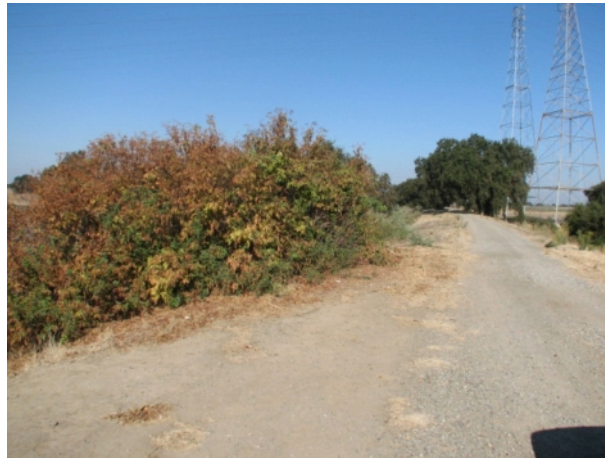
Levee Mile Report Line	2
Start Levee Mile	0.08
End Levee Mile	0.08
Location	Water Side
Category	Earthen Levee
Item	Vegetation

Photo of unacceptable vegetation on levee slope.

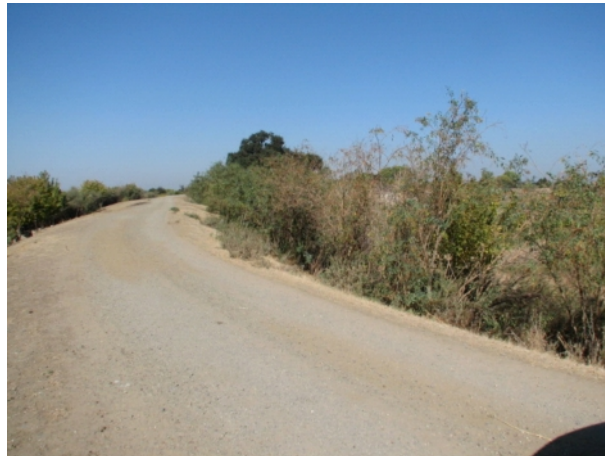
Levee Mile Report Line	7
Start Levee Mile	0.40
End Levee Mile	0.66
Location	Land Side
Category	Earthen Levee
Item	Vegetation

Photo of brush on landside toe limits visibility and accessibility.

6	0.34	0.34	Earthen Levee	Encroachments	LS	M	Debris	37.810045 ° -121.411527 °	37.810045 ° -121.411527 °	20
7	0.40	0.66	Earthen Levee	Vegetation	LS	M	Elderberries are blocking visibility and flood fight capability. Inspector Comments: Elderberries and othe brush block access and visibility.	37.810157 ° -121.412928 °	37.812395 ° -121.415813 °	8 Y
8	0.42	0.43	Supplemental	DWR Erosion Survey	WS	U	Inspector Comments: 2009: Updated pictures; pocket erosion with exposed tree roots; protruding rip rap is creating an eddy, scouring the levee slope; site is same as RM28.4, LM0.30; previously rated "U" [2009 SiteID:RD2089U2RM28.35]	37.809960 ° -121.413200 °	37.809960 ° -121.413200 °	1
9	0.69	0.85	Earthen Levee	Vegetation	WS	U	Remove the wild growth other than native grasses from the levee slopes.	37.812658 ° -121.415193 °	37.814843 ° -121.414732 °	10
10	0.80	0.80	Earthen Levee	Vegetation	CR	U	Elderberries are blocking visibility and flood fight capability.	37.814070 ° -121.414325 °	37.814070 ° -121.414325 °	21

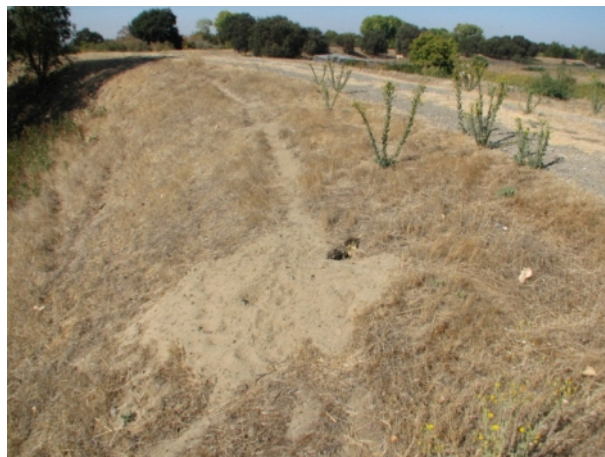
Levee Mile Report Line	12
Start Levee Mile	0.88
End Levee Mile	0.91
Location	Land Side
Category	Earthen Levee
Item	Animal Control

Photo of active rodent burrow on waterside slope.

11	0.85	1.37	Earthen Levee	Crown Surface / Depressions / Rutting	CR	C	Keep the crown roadway free of vegetation. Inspector Comments: Crown appeared to be in good shape.	37.814830 ° -121.414718 °	37.819362 ° -121.419625 °	12
12	0.88	0.91	Earthen Levee	Animal Control	LS	M	Exterminate rodents and backfill and compact or grout burrows. Inspector Comments: Actibe rodent burrows and both sides of levee.	37.814978 ° -121.415117 °	37.814898 ° -121.415653 °	13 Y
13	1.04	1.37	Earthen Levee	Vegetation	LS	C	Remove the wild growth other than native grasses from the levee slopes.	37.815352 ° -121.417838 °	37.819360 ° -121.419625 °	15
14	1.04	1.37	Earthen Levee	Vegetation	WS	M	Remove the wild growth other than native grasses from the levee slopes. Inspector Comments: Improvements made using an arm mower however vegetation remains obstructive.	37.815353 ° -121.417840 °	37.819358 ° -121.419625 °	16

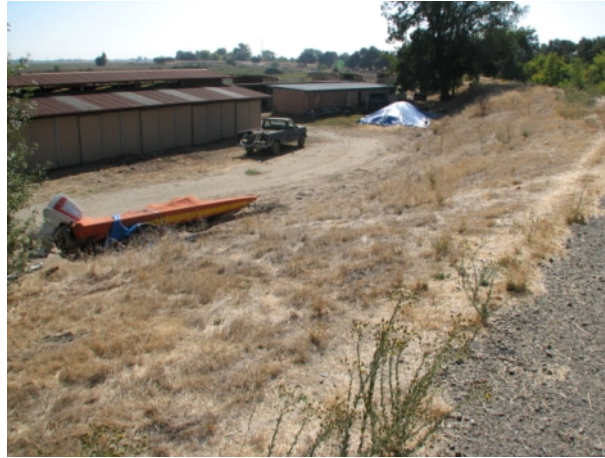
Levee Mile Report Line	19
Start Levee Mile	1.28
End Levee Mile	1.33
Location	Water Side
Category	Earthen Levee
Item	Encroachments

Boat and equipment stored within 10-ft of levee slope are an encroachment.

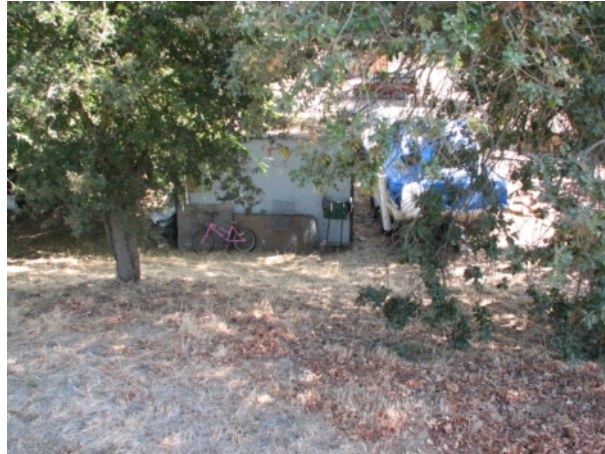
Levee Mile Report Line	19
Start Levee Mile	1.28
End Levee Mile	1.33
Location	Water Side
Category	Earthen Levee
Item	Encroachments

Buildings and patio decks are built within 10-ft of the levee slope.
